Reconstruction of historical Rocky Flats operations &
identification of release points : project tasks 3&4, final draft
report

Reconstruction of Historical Rocky Flats Operations & Identification of Release Points

Prepared by ChemRisk for the Colorado Department of Health

AUGUST 1992

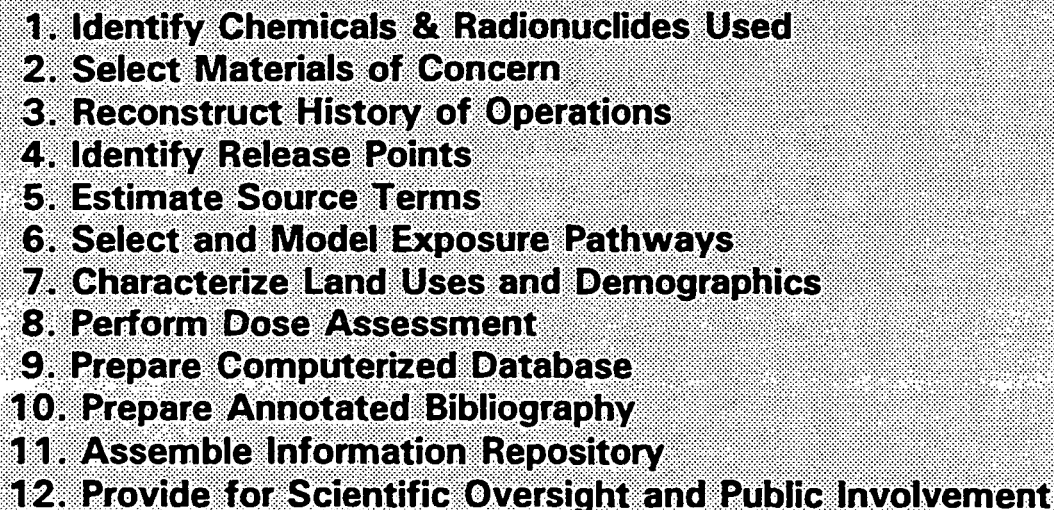
FIGURE 1-1: TASKS OF THE ROCKY FLATS TOXICOLOGIC REVIEW AND DOSE RECONSTRUCTION PROJECT

- 1. Identify Chemicals & Radionuclides Used**
 - 2. Select Materials of Concern**
 - 3. Reconstruct History of Operations**
 - 4. Identify Release Points**
 - 5. Estimate Source Terms**
 - 6. Select and Model Exposure Pathways**
 - 7. Characterize Land Uses and Demographics**
 - 8. Perform Dose Assessment**
 - 9. Prepare Computerized Database**
 - 10. Prepare Annotated Bibliography**
 - 11. Assemble Information Repository**
 - 12. Provide for Scientific Oversight and Public Involvement**

The Toxicologic Review and Dose Reconstruction Project is broken into the twelve tasks depicted in Figure 1-1. The first several tasks center around what was thought to be the most important contribution that the project could make to further understanding of the potential health impacts of the Rocky Flats Plant, that being a more comprehensive look at all the materials and amounts of materials which have been used at the plant since 1952.

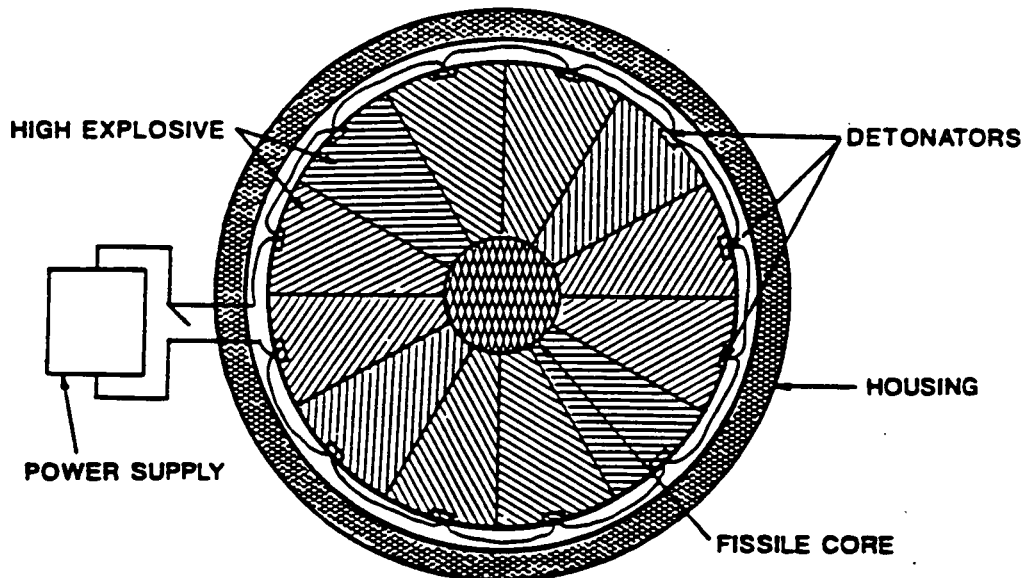
IMPLOSION TYPE NUCLEAR DEVICE

Since 1958, pit designs have remained largely the same, although the relative amounts of the materials used, dimensions, and a few other design features of the units have varied from model to model. The primary materials of construction have generally remained plutonium, uranium, beryllium, aluminum, and stainless steel, however the relative proportions have varied between models. Some models incorporated some more exotic materials, such as cadmium, vanadium, silver, and gold, but the amounts have been relatively minor in comparison to the primary five materials. The plant has also performed "Special Order" work. This type of work is outside the production of weapon components, but most often involved prototype development work. Special fabrication, testing, and assembly are provided for weapons development programs. For example, the work may involve the production of a prototype pit that incorporates different materials or geometries. In some cases, Special Order work has involved work indirectly related to war reserve programs, such as the development of safer shipping containers and transportation vehicles for nuclear materials and weapons (USDOE, 1980).

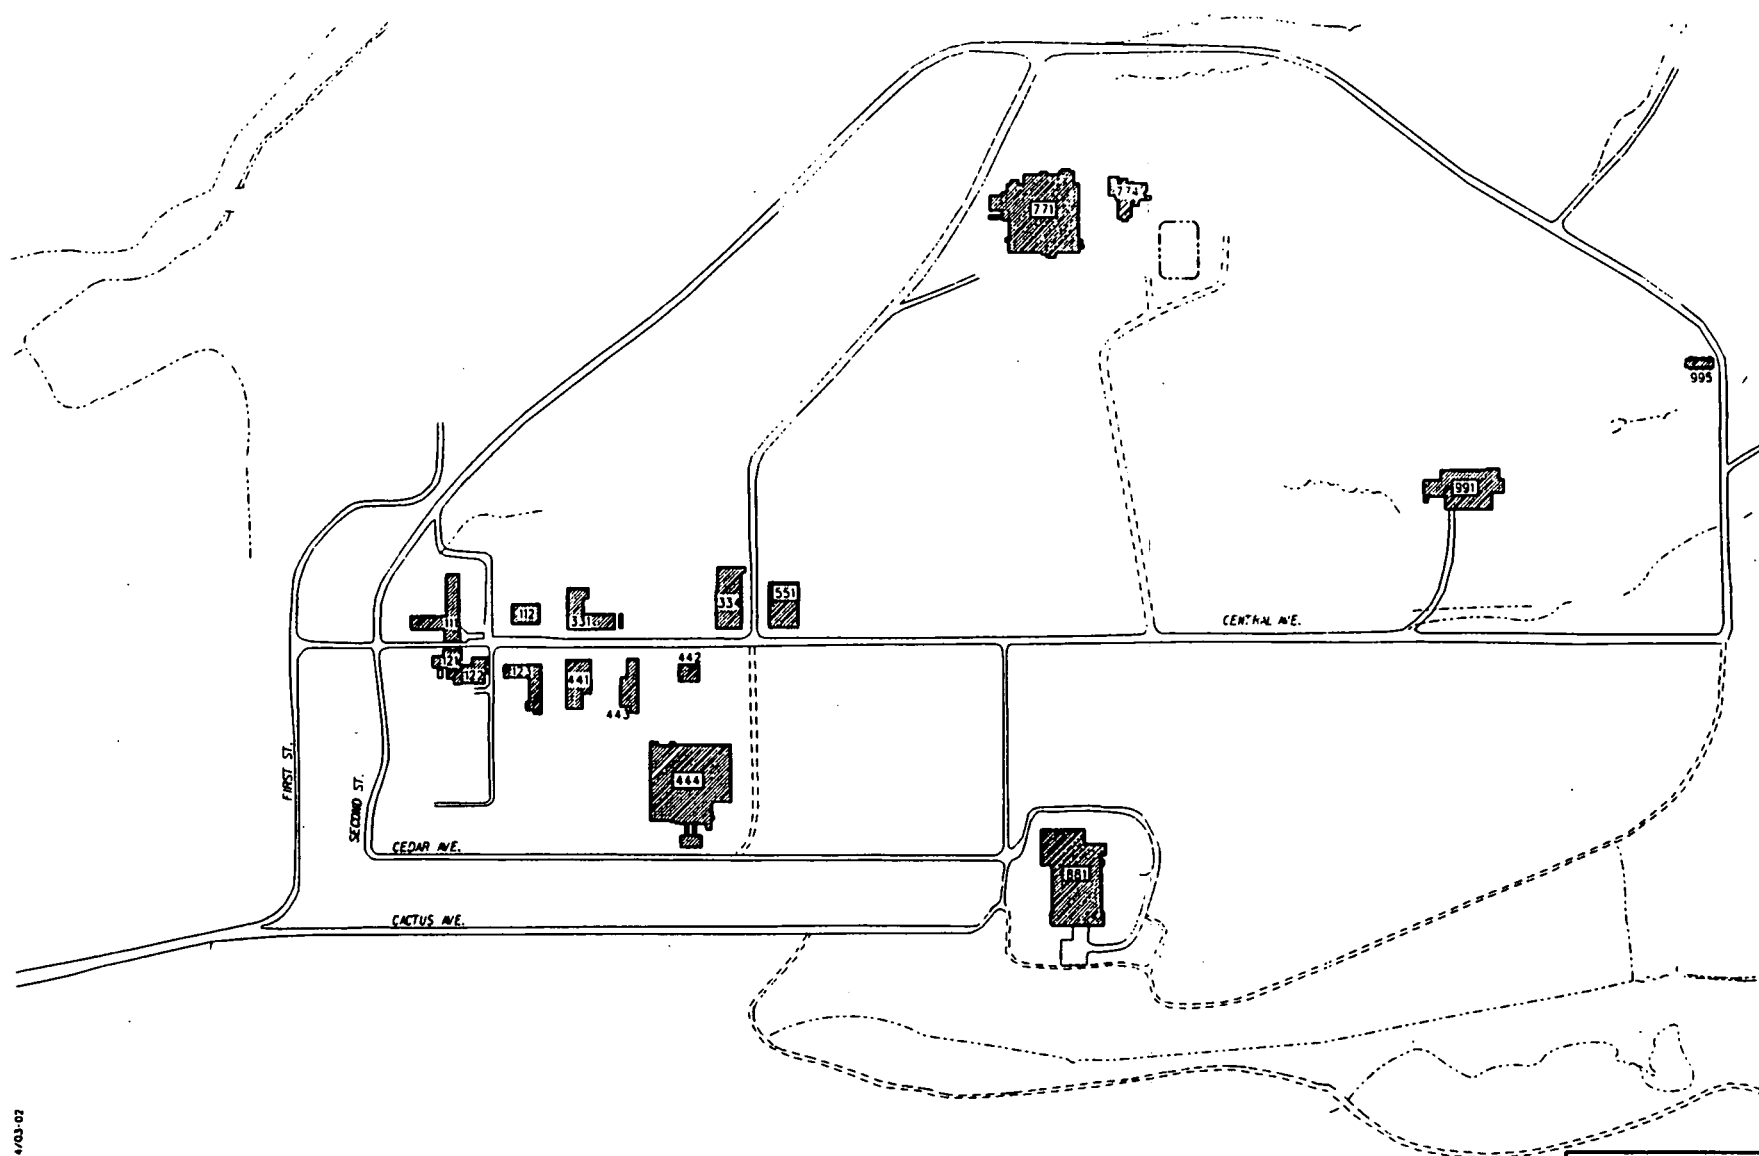
FIGURE 3-2
ROCKY FLATS FACILITY
AS IT APPEARED IN 1953

NO	DESCRIPTION
111	ADMINISTRATION
112	CAFETERIA
121	PLANT PROTECTION
122	MEDICAL
123	HEALTH PHYSICS
331	GARAGE AND FIRE STATION
334	GENERAL SHOP, MAINTENANCE
441	PRODUCTION SUPPORT
442	LAUNDRY
443	HEATING PLANT
444	DEPLETED URANIUM
551	MANUFACTURING
551	GENERAL WAREHOUSE
771	PLUTONIUM RECOVERY &
774	MANUFACTURING
774	WASTE TREATMENT PLANT
881	ENRICHED URANIUM RECOVERY &
881	MANUFACTURING
991	ASSEMBLY
995	SEWAGE TREATMENT FACILITY

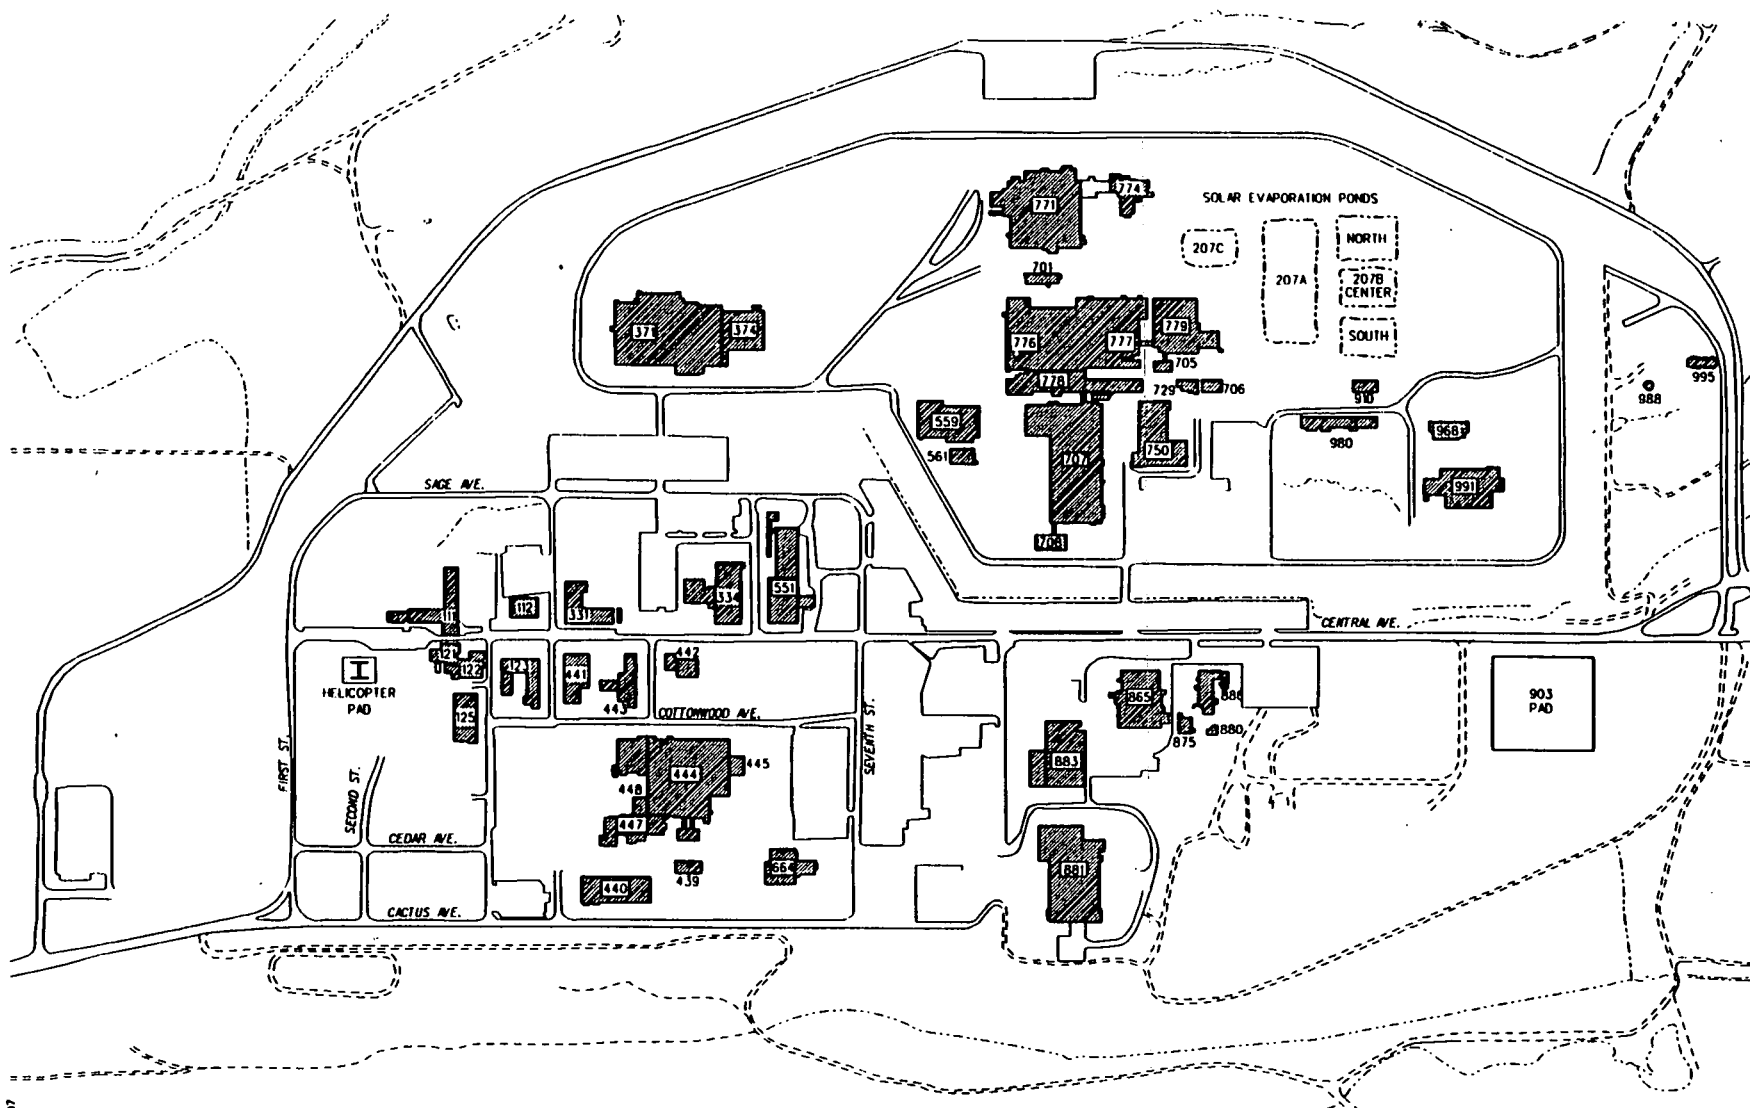
FIGURE 3-7
ROCKY FLATS FACILITY
AS IT APPEARED IN 1980

NO.	DESCRIPTION
111	ADMINISTRATION
112	CAFETERIA
121	PLANT PROTECTION
122	MEDICAL
123	HEALTH PHYSICS
125	STANDARDS LABORATORY
331	GARAGE AND FIRE STATION
334	GENERAL SHOP MAINTENANCE
371	PLUTONIUM RECOVERY
374	PROCESS WASTE TREATMENT
438	REMOTE HANDLING
440	MODIFICATION CENTER
441	PRODUCTION SUPPORT
442	FILTER TEST LABORATORY
443	HEATING PLANT
444	DEPLETED URANIUM AND
445	DEUTERIUM OPERATIONS
446	CARBON STORAGE
447	MANUFACTURING
448	SHIPPING, RECEIVING, STORAGE
449	MANUFACTURING SUPPORT
551	GENERAL WAREHOUSE
558	PLUTONIUM ANALYTICAL LAB
561	FILTER PLUTONIUM BUILDING
684	WASTE STORAGE AND SHIPPING
701	PILOT PLANT DEVELOPMENT
705	COATINGS LABORATORY
708	LIBRARY
711	MANUFACTURING
718	COMPRESSOR BUILDING
729	FILTER PLUTONIUM BUILDING
730	PRODUCTION ENGR. SUPPORT
731	PLUTONIUM RECOVERY
734	WASTE TREATMENT PLANT
735	MANUFACTURING
737	ASSEMBLY
738	SERVICE BUILDING
739	PLUTONIUM DEVELOPMENT
883	MATERIAL & PROCESS DEVELOPMENT
885	FILTER PLUTONIUM BUILDING

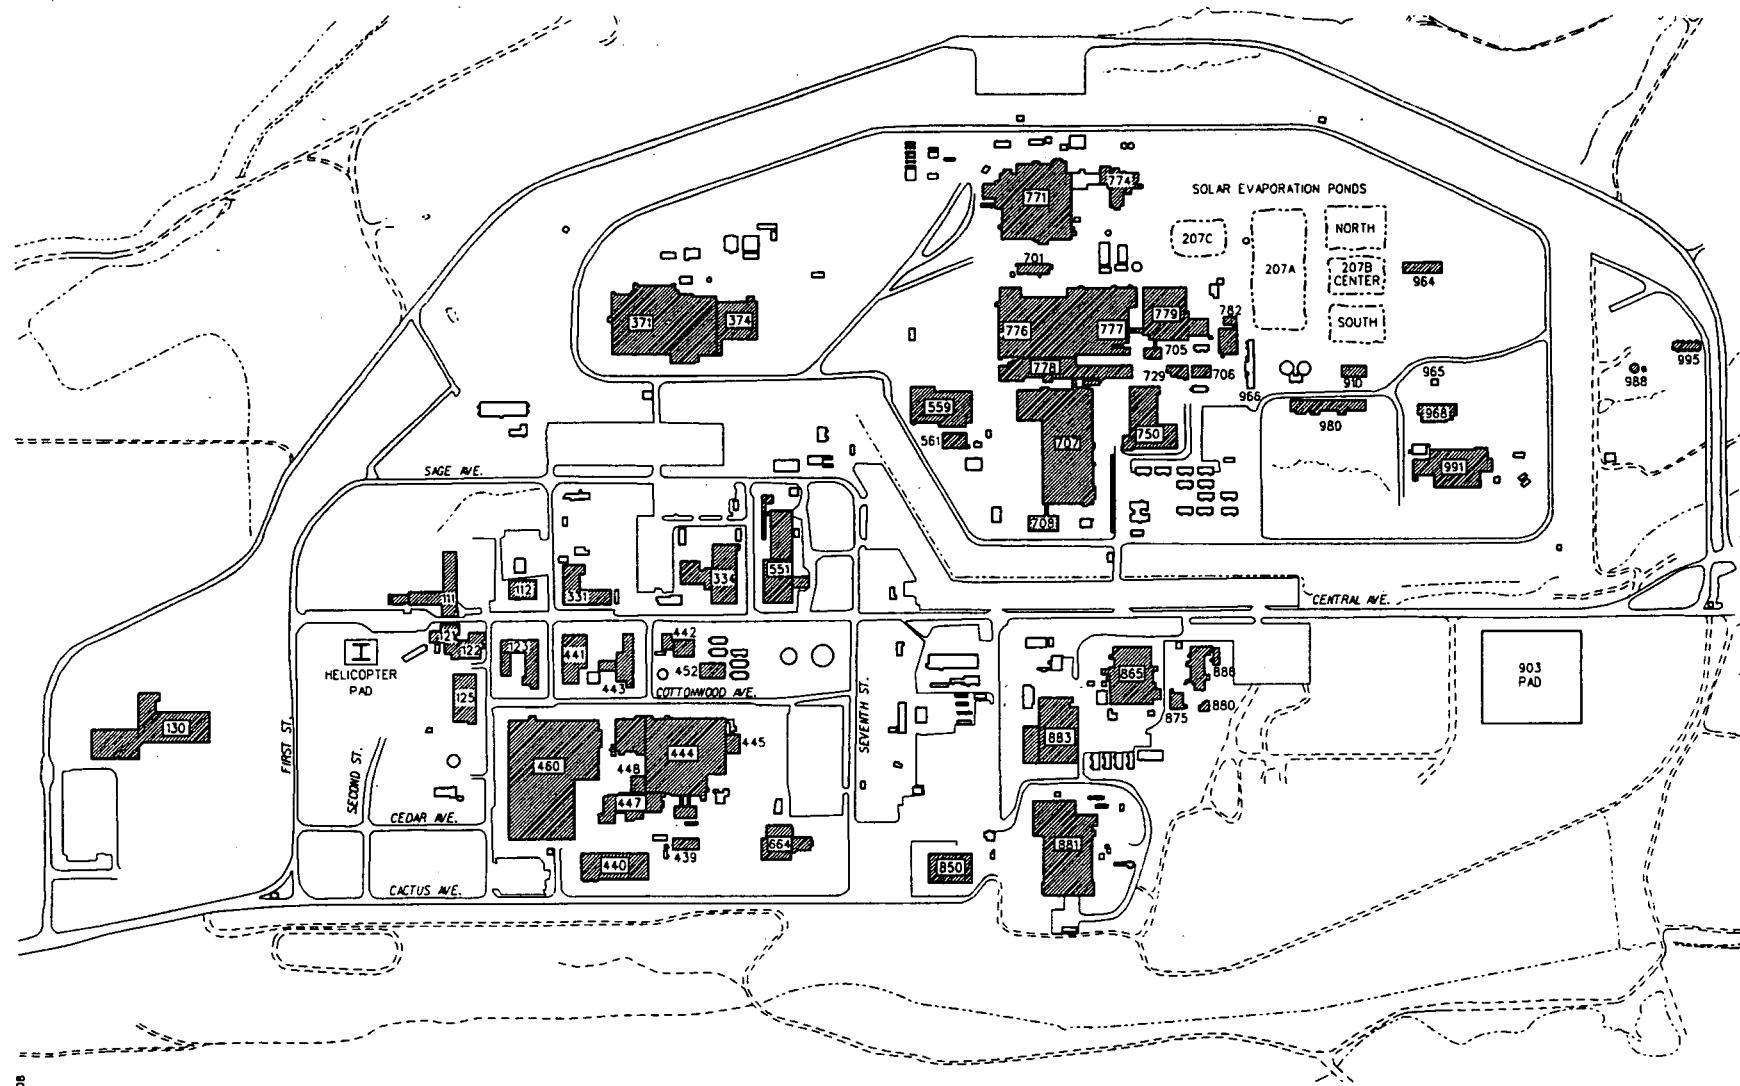
FIGURE 3-8
ROCKY FLATS FACILITY
AS IT APPEARED IN 1990

NO.	DESCRIPTION
111	ADMINISTRATION
112	CAFETERIA
121	PLANT PROTECTION
122	MEDICAL
123	HEALTH PHYSICS
125	STANDARDS LABORATORY
130	PRODUCTION SUPPORT
331	GARAGE AND FIRE STATION
334	GENERAL SHOP MAINTENANCE
371	PLUTONIUM RECOVERY
374	PROCESS WASTE TREATMENT
438	REMOTE HANDLING
440	MODIFICATION CENTER
441	PRODUCTION SUPPORT
442	FILTER TEST LABORATORY
443	HEATING PLANT
444	DEPLETED URANIUM AND BERYLLIUM OPERATIONS
445	CARBON STORAGE
447	MANUFACTURING
448	SHIPPING, RECEIVING, STORAGE
452	MANUFACTURING SUPPORT
480	CONSOLIDATED MANUFACTURING
531	GENERAL WAREHOUSE
559	PLUTONIUM ANALYTICAL LAB
561	FILTER PLENUM BUILDING
564	WASTE STORAGE AND SHIPPING
701	PILOT PLANT DEVELOPMENT
705	COATINGS LABORATORY
706	LIBRARY
707	MANUFACTURING
708	COMPRESSOR BUILDING
729	FILTER PLENUM BUILDING
750	PRODUCTION ENGR. SUPPORT
771	PLUTONIUM RECOVERY
774	WASTE TREATMENT PLANT
776	MANUFACTURING
777	ASSEMBLY
778	SERVICE BUILDING
779	PLUTONIUM DEVELOPMENT
782	FILTER PLENUM BUILDING

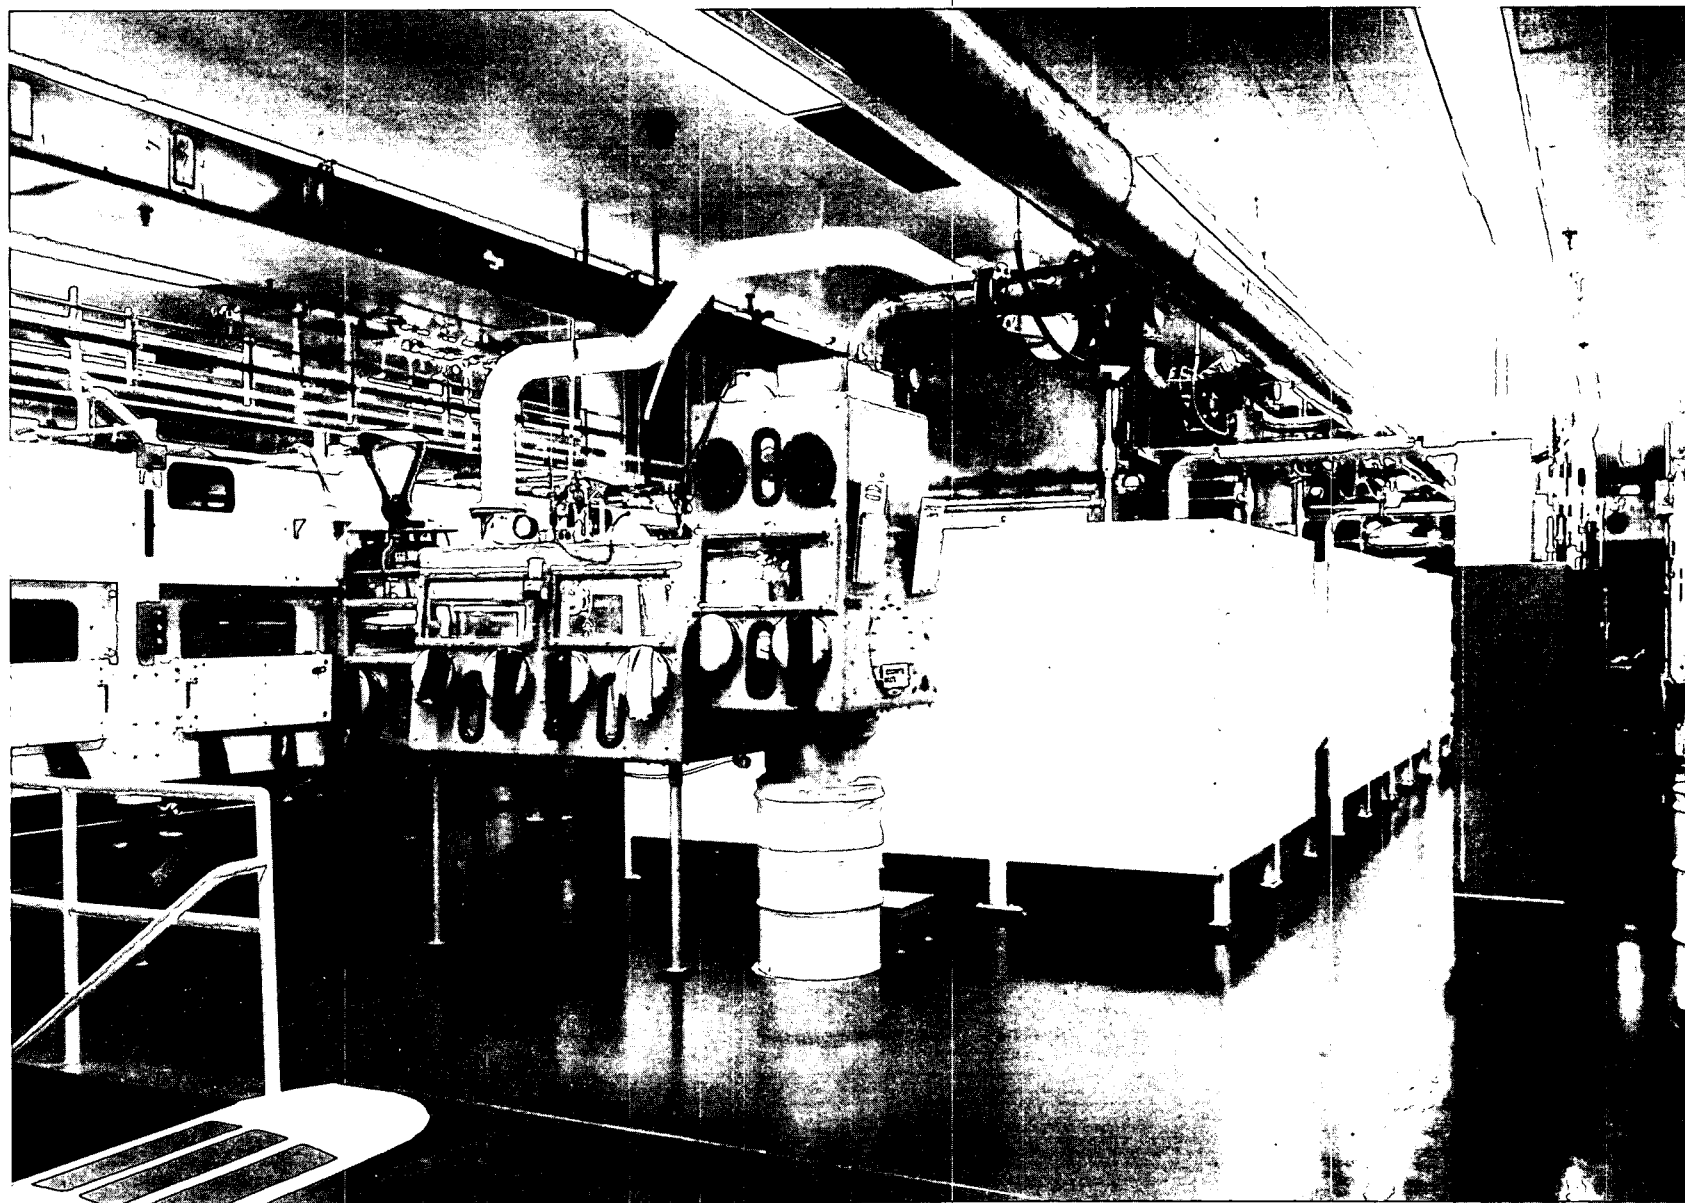
FIGURE 3-10. A TYPICAL GLOVE-BOX LINE. GLOVE-BOXES ARE WIDELY USED AT ROCKY FLATS FOR CONTAINMENT DURING MATERIAL PROCESSING.

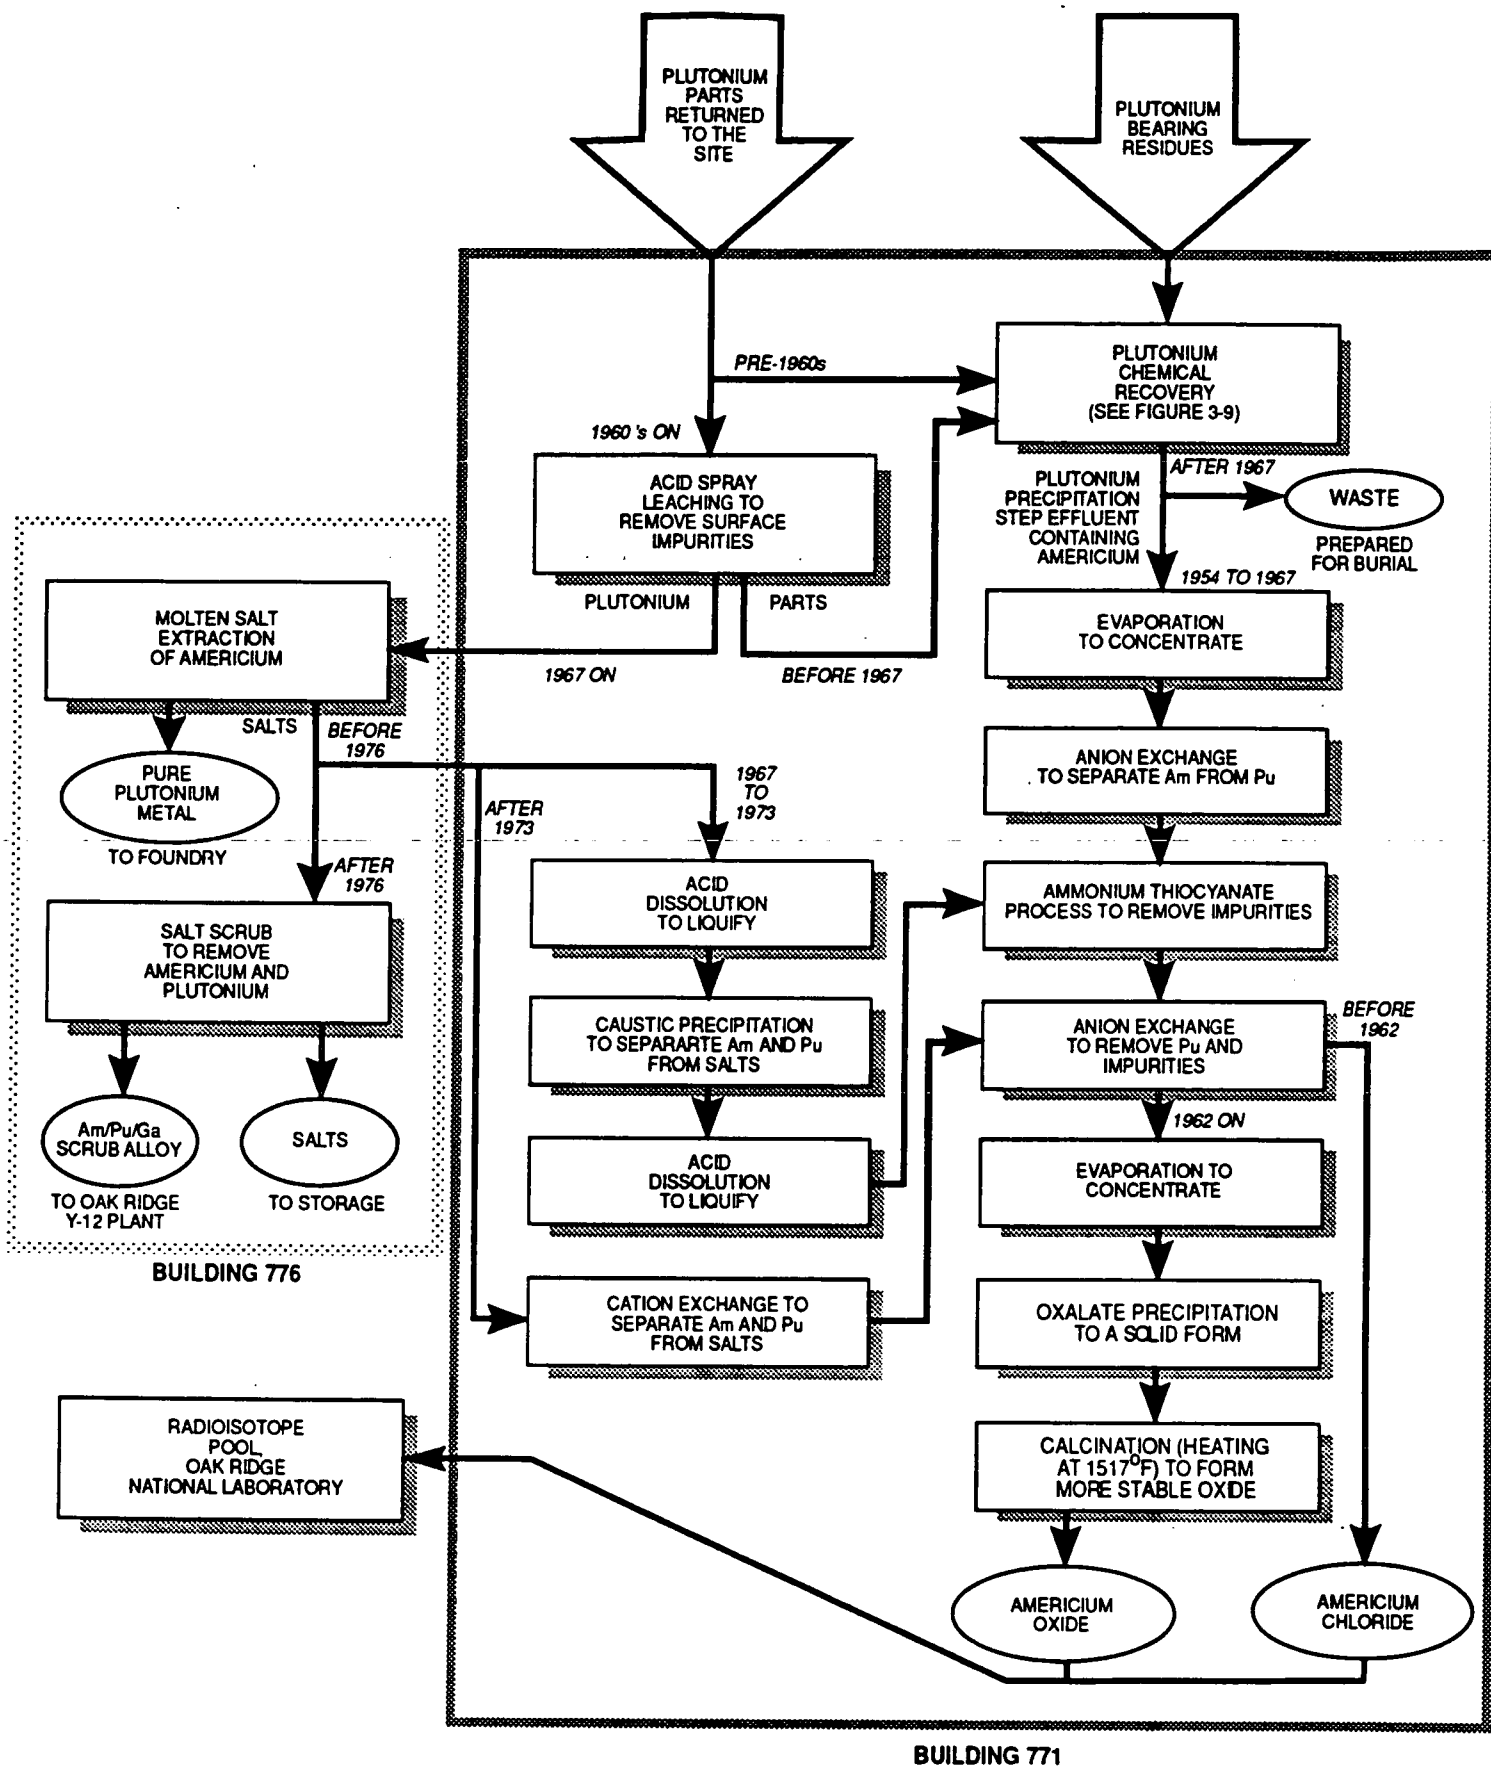
FIGURE 3-12
HISTORICAL AMERICIUM EXTRACTION,
RECOVERY, AND PURIFICATION PROCESSES

A slight change was made to the ammonium thiocyanate process in 1962 by adding oxalate precipitation and calcination steps, which resulted in an americium oxide product that was preferred because of its stability. Nonetheless, the process during this entire period was "messy," resulted in a disproportionate amount of waste solutions, and created personnel exposure problems due to the relatively large amount of manual operations and maintenance required. Worst of all, the americium recovery rate was as low as ten to twenty percent (Crisler, 1991).

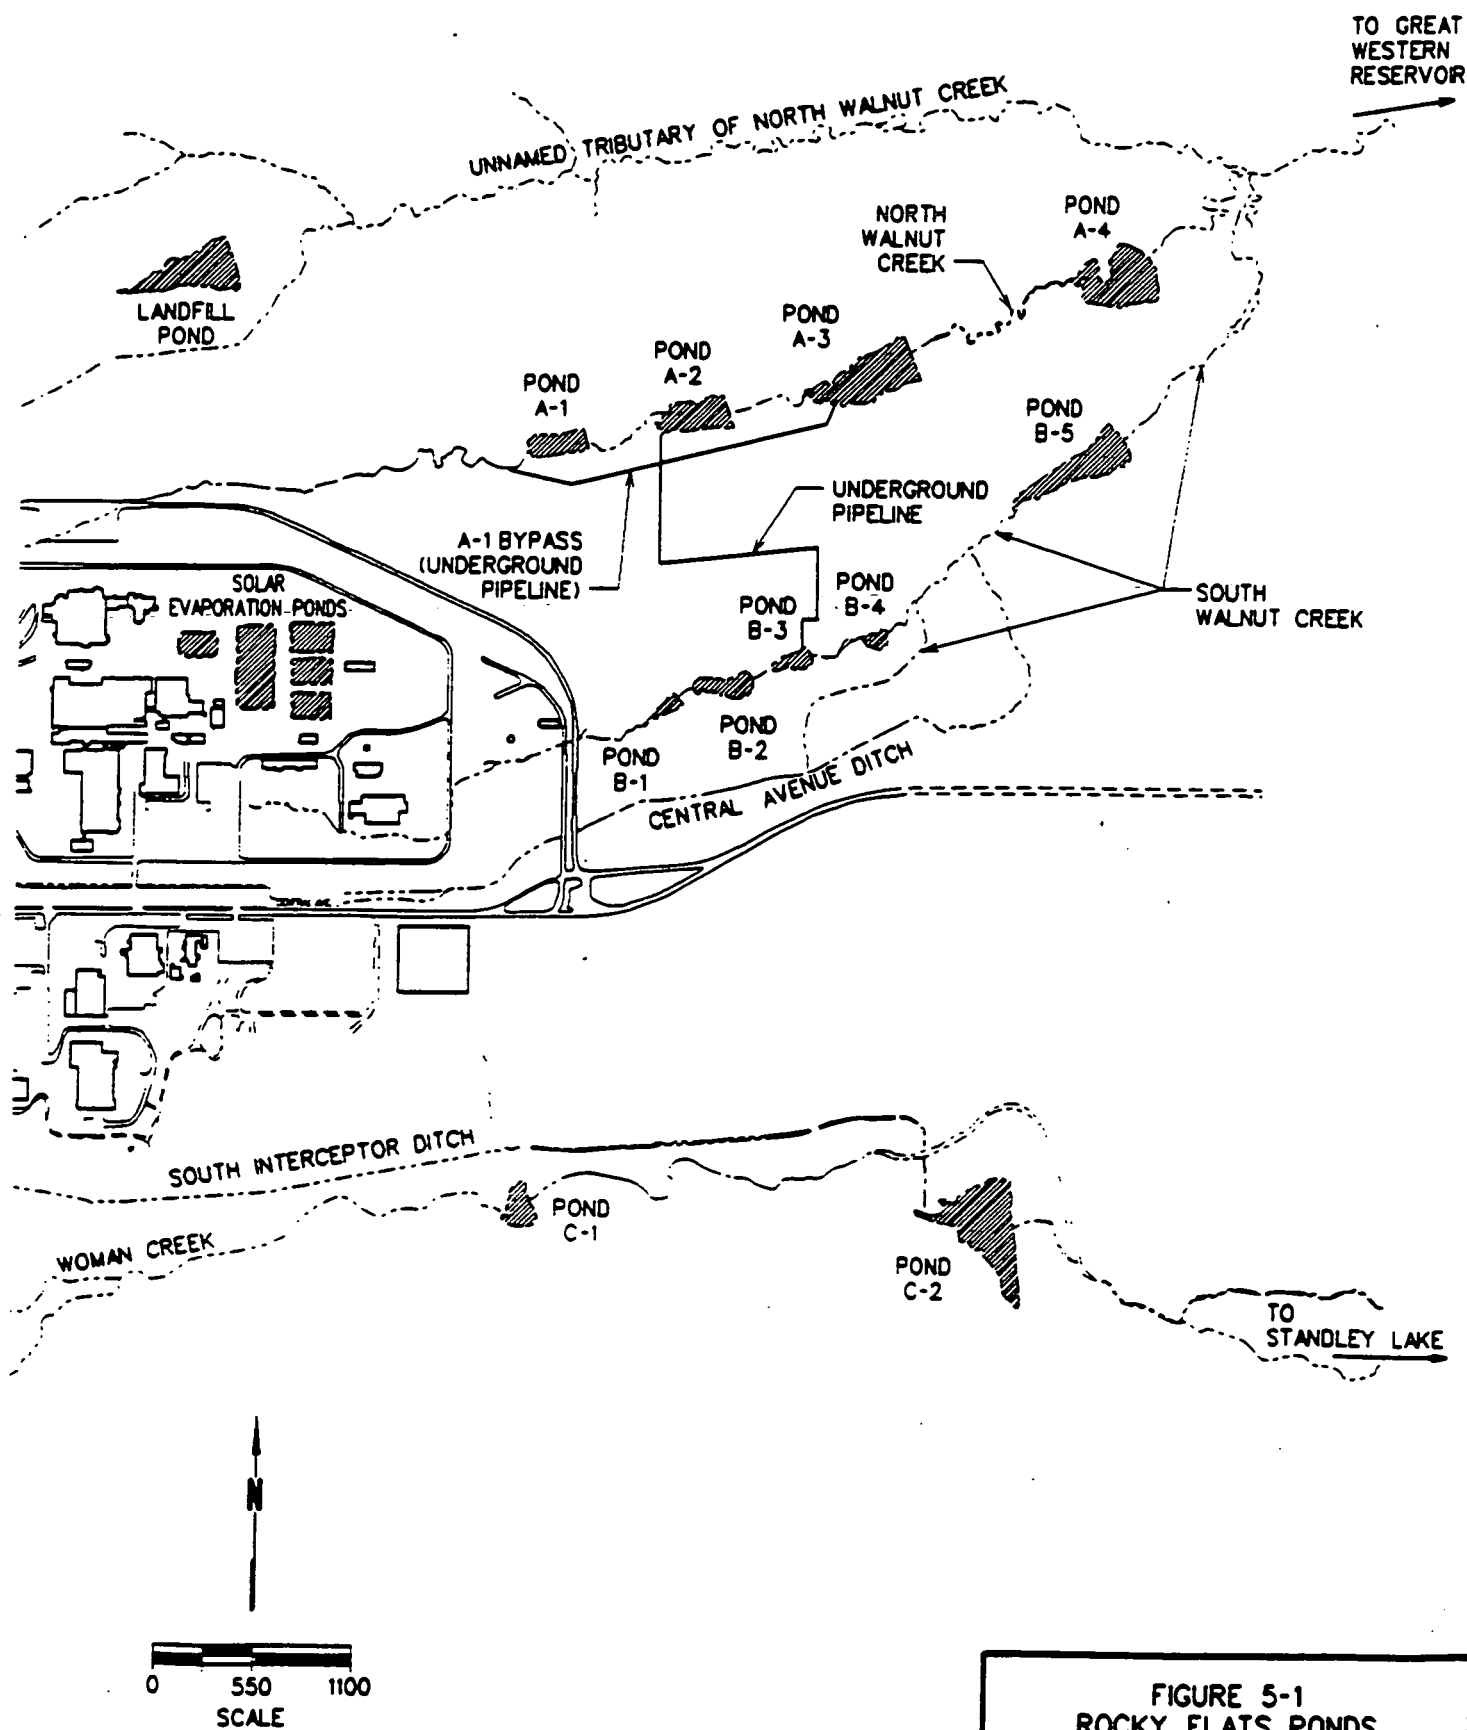
Plant Support activities of potential relevance to off-site exposures include Criticality Safety, the various service Laboratories, Filter Testing, and Laundry Services.

From plant start-up in 1952 to 1953, low level contaminated waste containing nitrates and radioactive substances (laundry wastewater including plutonium and uranium) was discharged directly into North Walnut Creek. From 1953, when Pond A-1 was constructed, to 1957, when low-level contaminated waste was rerouted to the process waste treatment facility, low-level waste was discharged into Pond A-1 for eventual discharge into North Walnut Creek. In pre-1970s documents, Pond A-1 is often referred to as Pond 1.

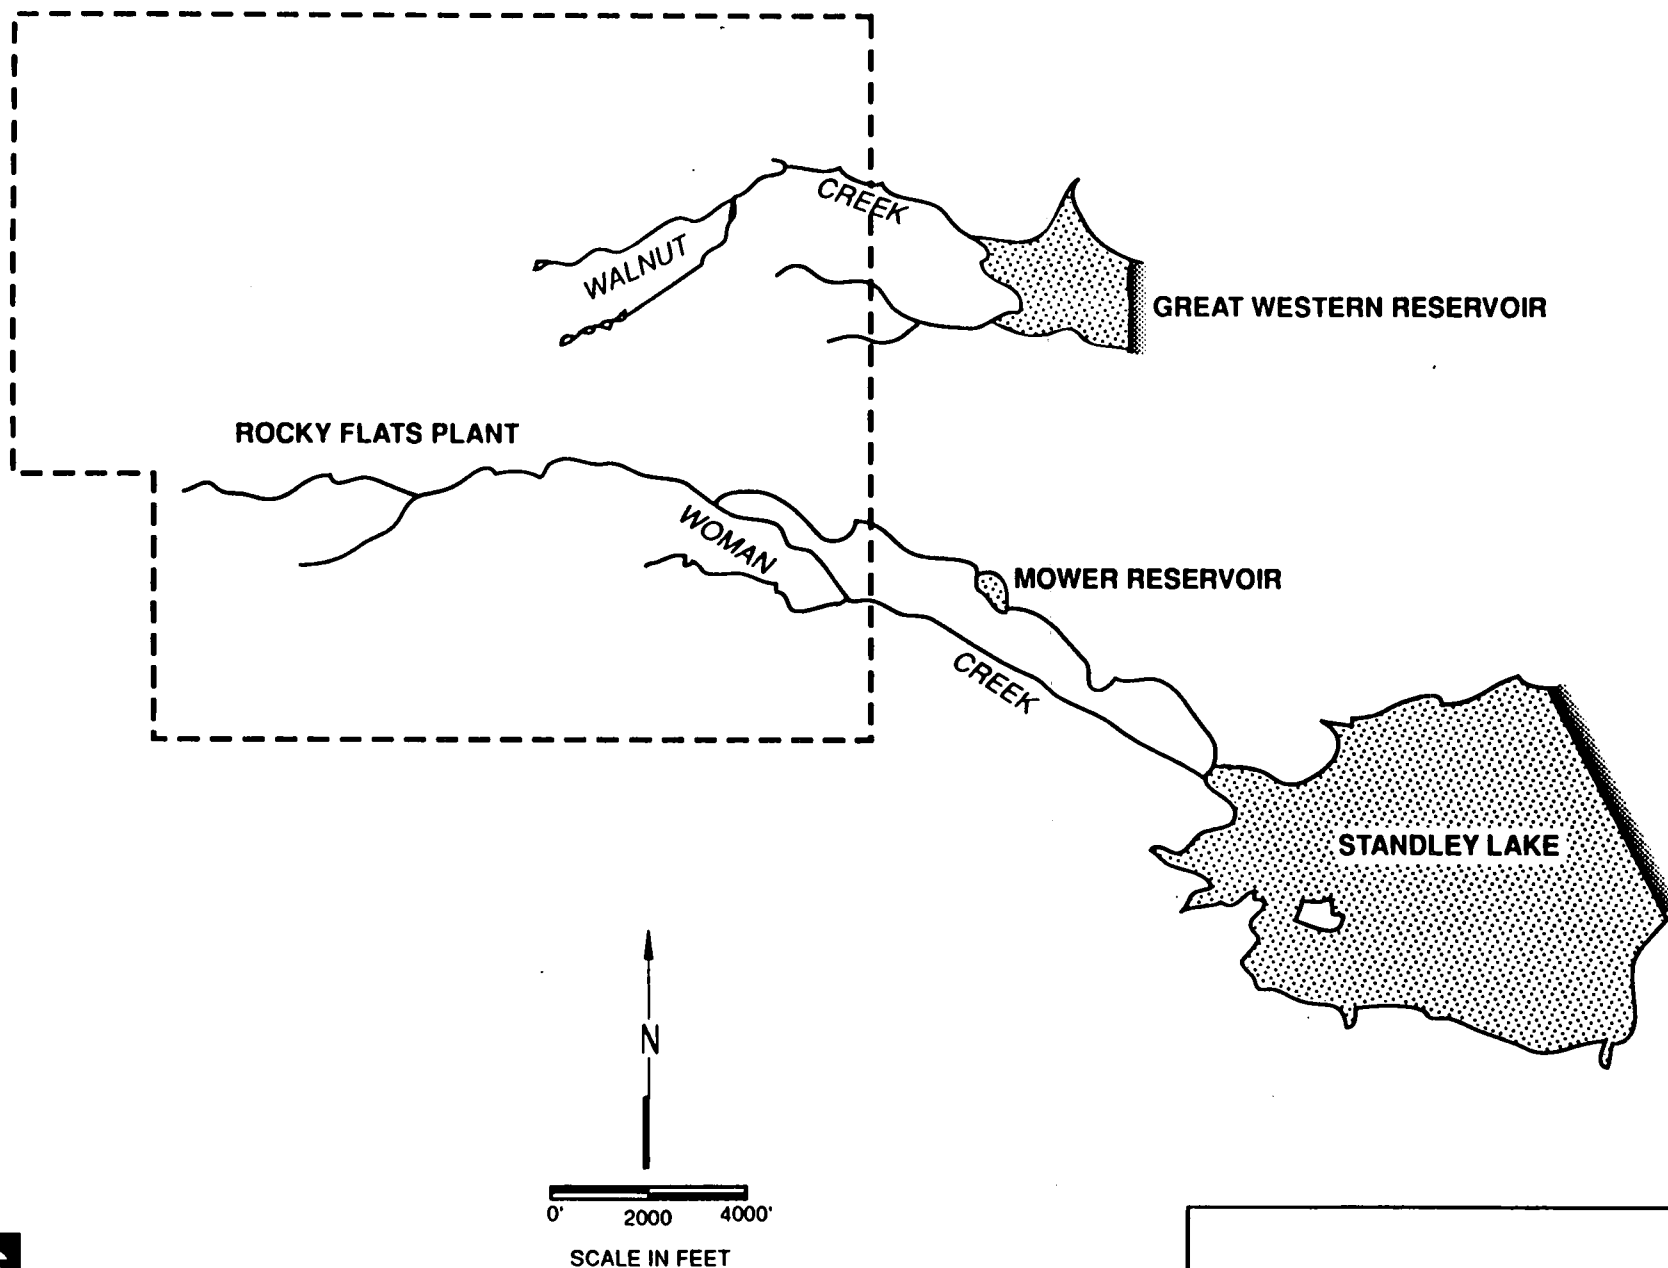
FIGURE 5-3
MAJOR RESERVOIRS NEAR ROCKY FLATS

Great Western Reservoir is located approximately 1.5 miles east of the Rocky Flats Plant's eastern boundary. Great Western was constructed in 1904 by the Great Western Reservoir and Canal Company. The reservoir receives surface water runoff from Clear Creek through Church Ditch, Coal Creek through McKay Ditch, Upper Church Ditch, and Walnut Creek. Originally, the reservoir was 42 feet deep and had a storage capacity of 1420 acre-feet. In 1955, the Turnpike Land Company bought the reservoir and established the Broomfield Heights Mutual Service Association to own and operate water and sewer utilities for the Broomfield Heights development. In 1958, the reservoir was enlarged to its present storage capacity of 3250 acre-feet (1.06 billion gallons) and is 62 feet deep (Schnoor, 1991). In 1962, the City of Broomfield bought the water and sewer services from the Turnpike Land Company.

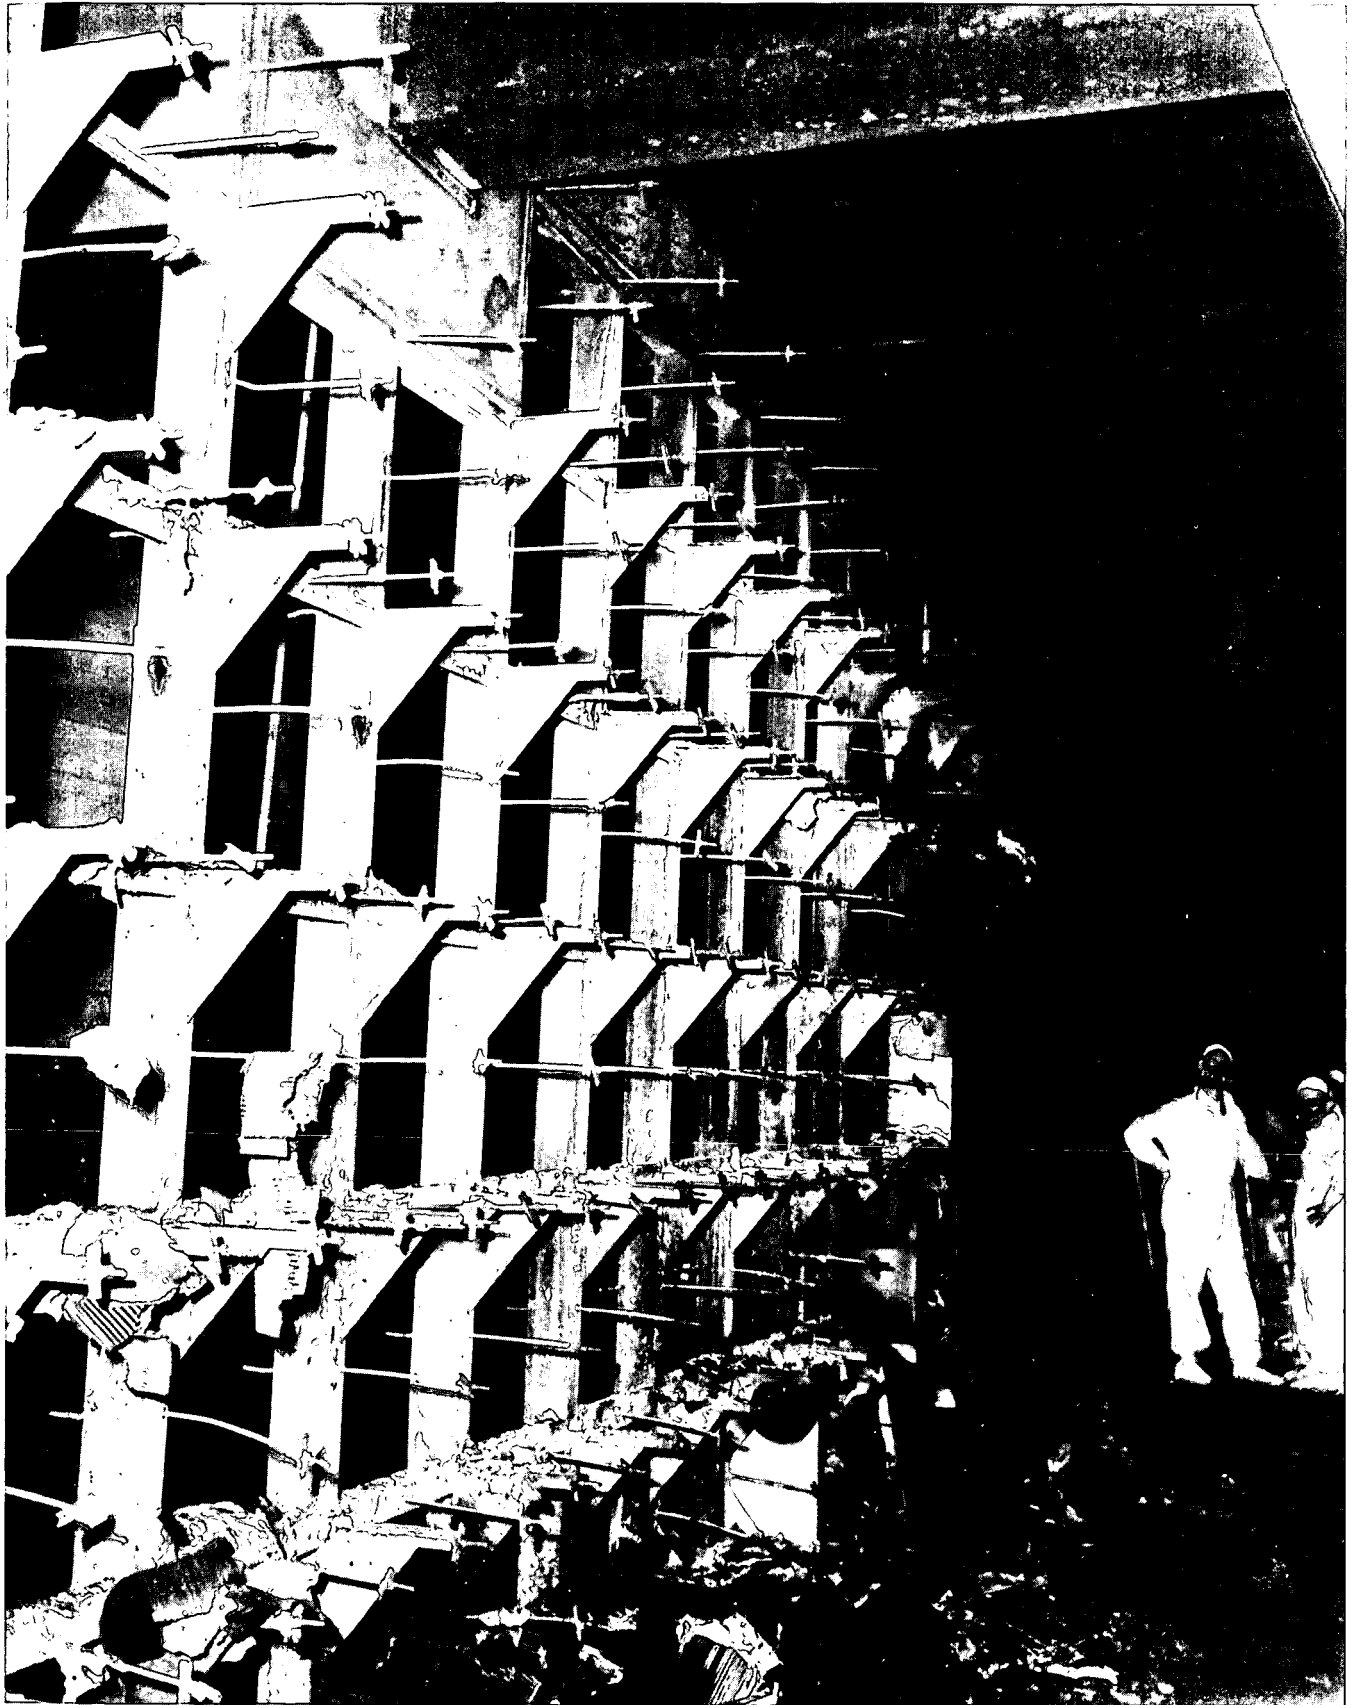
FIGURE 6-3. INTAKE SIDE OF BUILDING 771 EXHAUST FILTER BANK FOLLOWING THE 1957 FIRE. MANY OF THE FILTERS BURNED, AND SOME WERE PULLED OUT OF THEIR FRAMES TO LIMIT SPREAD OF THE FIRE. PARTIALLY BURNED FILTERS CAN BE SEEN ON THE FLOOR.

- 2:00 a.m. - Filter fire knocked down.
- 11:28 a.m. - Final fire out" (pages 14-17).
